**PRELIMINARY ASSESSMENT/
VISUAL SITE INSPECTION**

**MORTON INTERNATIONAL, INC., BATAVIA
(FORMERLY WHITTAKER CORPORATION,
BATAVIA COATINGS AND CHEMICALS DIVISION)
BATAVIA, ILLINOIS
ILD 095 309 647**

FINAL REPORT

Work Assignment No.	:	C05087
EPA Region	:	5
Site No.	:	ILD 095 309 647
Date Prepared	:	September 27, 1993
Contract No.	:	68-W9-0006
PRC No.	:	009-C05087IL9L
Prepared by	:	PRC Environmental Management, Inc. (Keith Foszcz)
Contractor Project Manager	:	Shin Ahn
Telephone No.	:	(312) 856-8700
EPA Work Assignment Manager	:	Kevin Pierard
Telephone No.	:	(312) 886-4448

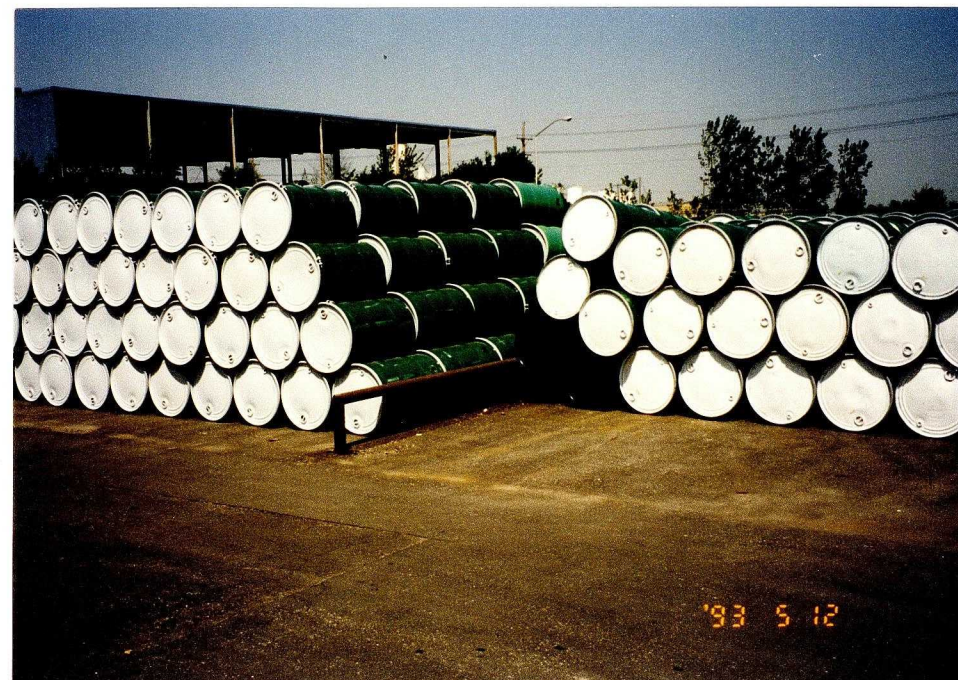
Observations: During the VSI, the unit contained empty drums for product shipping. PRC noted no evidence of release (see Photograph No. 1).

Photograph No. 1
 Orientation: East
 Description: Four-hundred-gallon totes of hazardous waste solvent were stored in this Former CSA until 1984. Sometime after waste storage ceased in this unit, the area was paved with asphalt and is currently used to store empty drums for product shipping.
 Location: SWMU 1
 Date: May 12, 1993

PRC recommends no further action for this SWMU at this time.

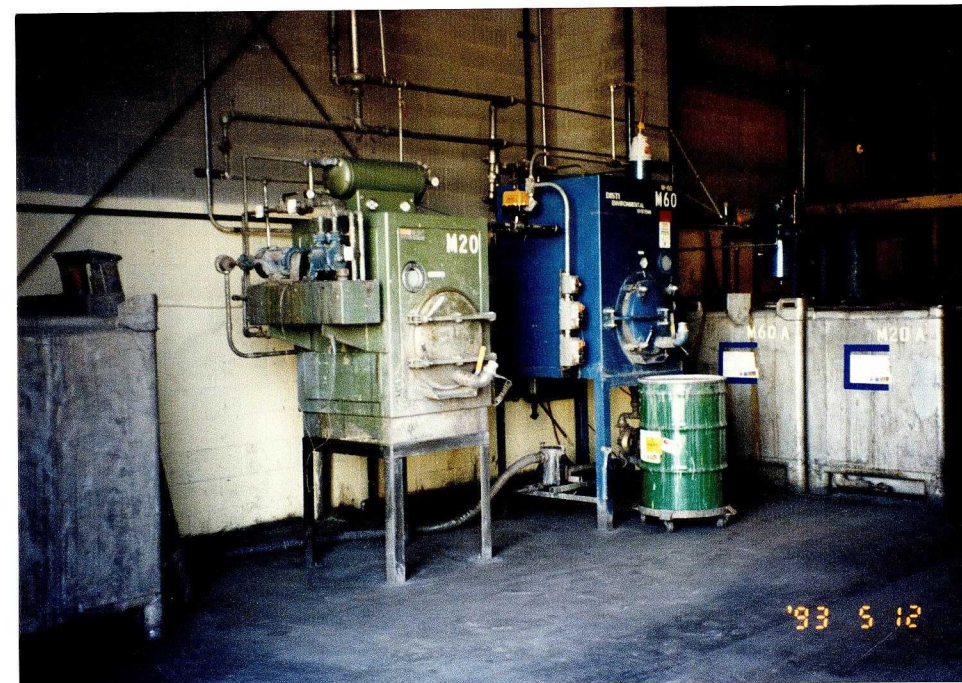
During the VSI, the unit was treating waste solvent. PRC noted no evidence of release (see Photograph No. 2).

Photograph No. 2
 Orientation: Southwest
 Description: Waste solvent is brought to these Distillation Units in 400-gallon totes for treatment. Still bottoms are pumped directly from the Distillation Units to SWMU 3. The drum in front of the unit on the right is used to collect nonpumpable still bottoms scraped out of the stills.
 Location: SWMU 2
 Date: May 12, 1993

Recommendations: PRC recommends no further action for this SWMU at this time.

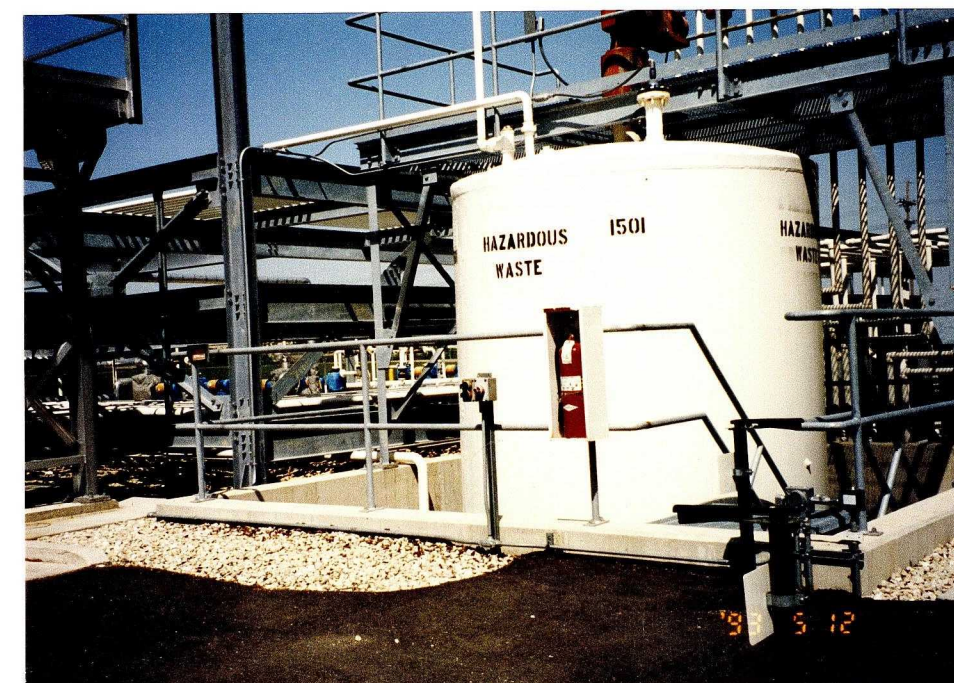
Observations: During the VSI, the containment pit was dry. A surface water drainage ditch is located about 15 feet south of the unit. The drainage ditch ultimately leads to the Fox River. PRC noted no evidence of release (see Photograph No. 3).

Photograph No. 3
 Orientation: Northeast
 Description: Still bottoms are pumped to this Waste Solvent AST from SWMU 2. The unit was formerly located about 25 feet north of its current location.
 Location: SWMU 3
 Date: May 12, 1993

Recommendations: PRC recommends that approval of the excavation backfilling at the former location of this unit continue as scheduled.

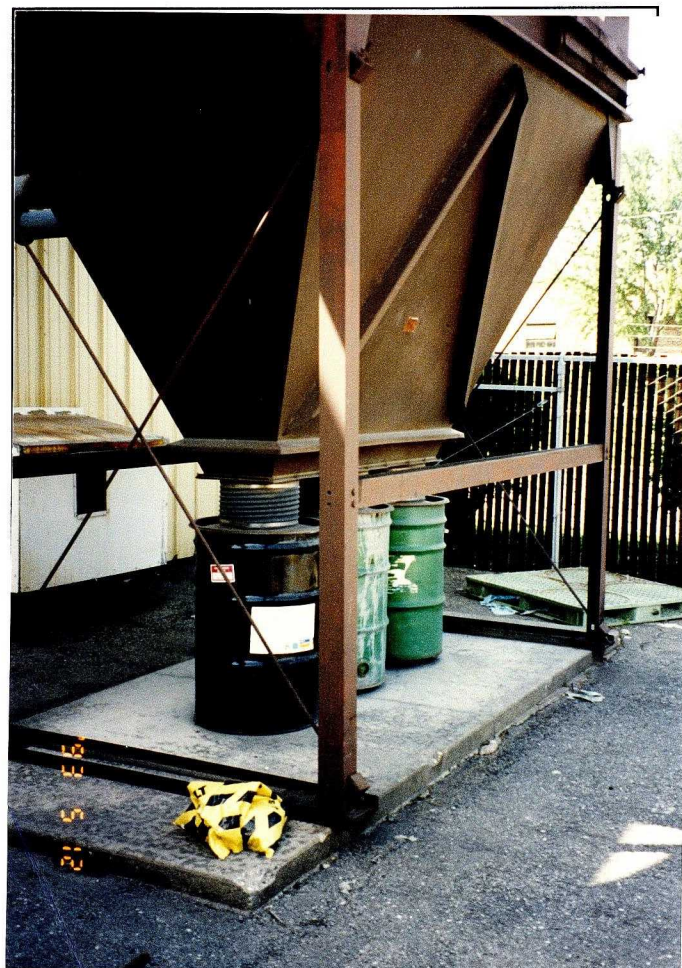
Photograph No. 4

During the VSI, the unit contained one nearly full drum and two empty drums. PRC noted no evidence of release (see Photograph No. 4).

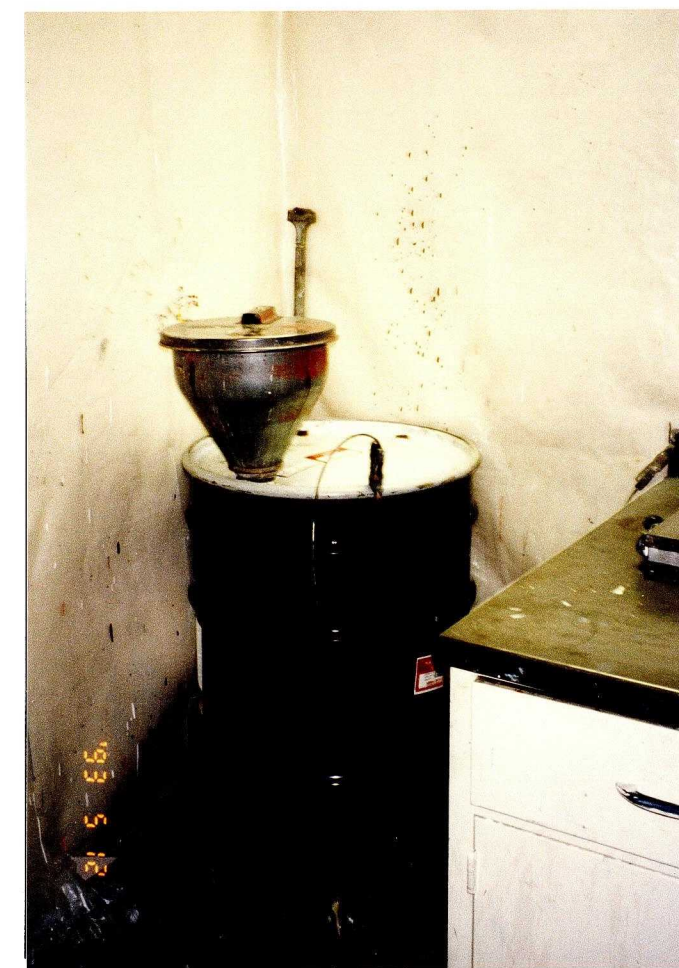
Photograph No. 5

Observations: During the VSI, the unit contained about 30 gallons of waste. PRC noted no evidence of release (see Photograph No. 5).

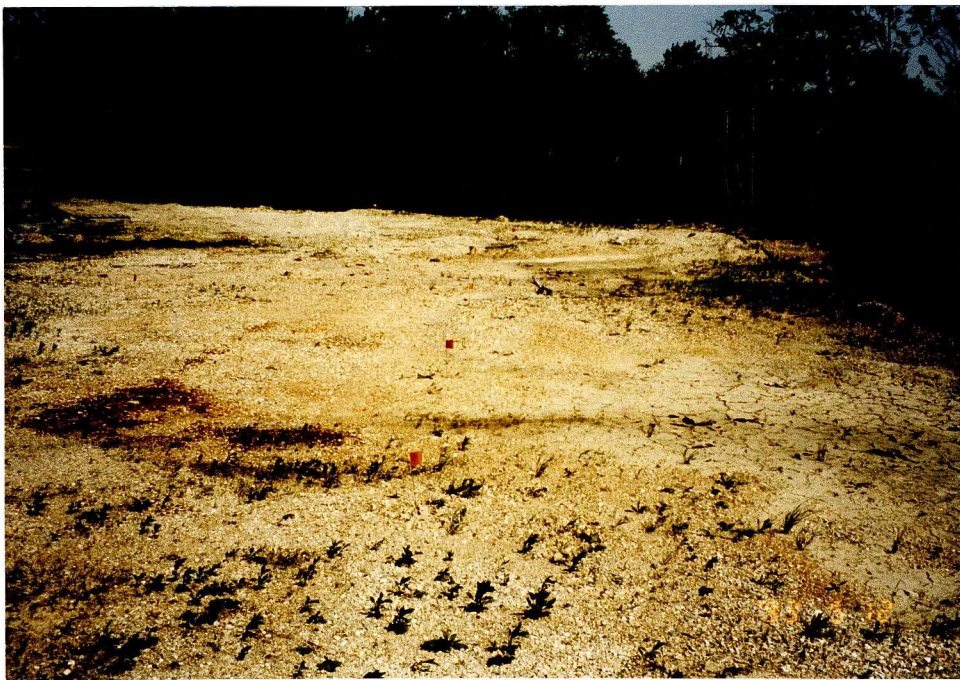
Observations: During the VSI, the unit was no longer at the site. The former location of the unit consisted of a graded gravel ground surface. A surface water drainage ditch is located about 20 feet south of the unit's former location. PRC noted no evidence of release (see Photograph No. 6).

Photograph No. 6
 Orientation: Southeast
 Location: SWMU 8
 Date: May 12, 1993
 Description: Volatile organic compound (VOC)-contaminated soil excavated from the former location of SWMU 3 was stored in this Former Waste Pile on a 20-mil-thick polyethylene liner. The orange flag marks sampling locations associated with the closure of this SWMU.

PRC recommends that RCRA closure continue as scheduled.

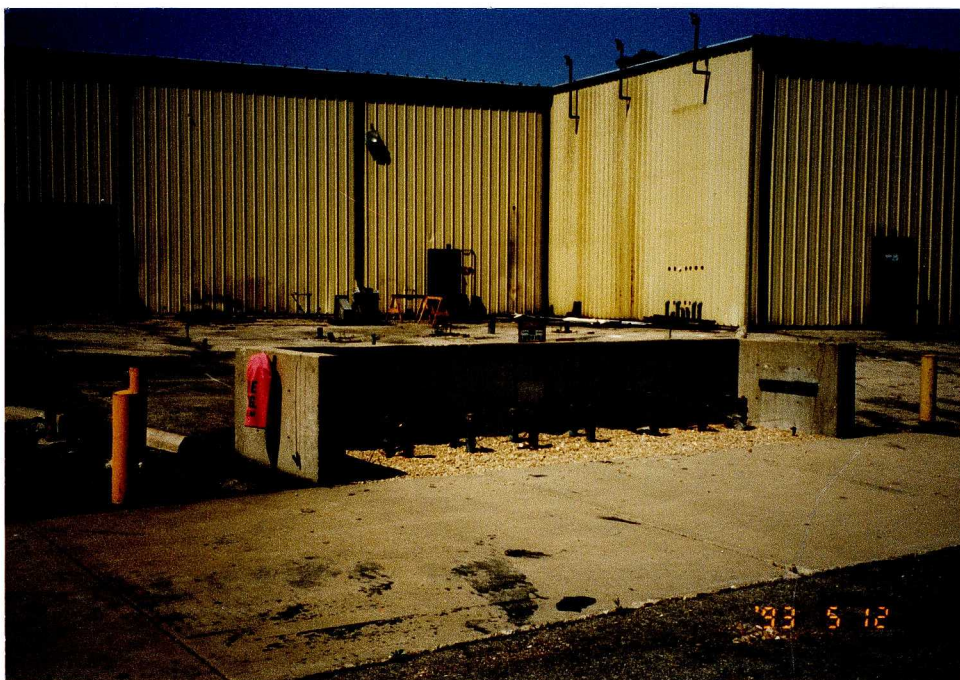
In October 1989, seven of 14 fill lines were found to be leaking in this tank farm. Groundwater samples collected from inspection ports in this area had total VOC concentrations exceeding 25,000 ppm. VOCs were identified in subsurface soils about 3 feet west of the tank farm fill area. Ethylbenzene, toluene, and total xylenes were detected at a total concentration of 0.35 ppm in one soil sample collected about 5 feet bgs and 3 feet west of the tank farm fill area. Four groundwater monitoring wells were installed in December 1989. Facility representatives stated that no VOCs have been detected in these wells. The potential for release to environmental media is summarized below.

Photograph No. 7
 Orientation: Northeast
 Location: AOC 1
 Date: May 12, 1993
 Description: The fill station for this Old UST Farm is shown in the foreground, and UST vent lines are shown in the background. The fill lines identified as leaking during 1989 tightness testing are painted red.

PRC recommends that remediation of contaminated soils continue with the removal of the UST farm under IEPA supervision. Soil sampling of the excavation should be conducted to verify that all contaminated soil has been removed during remediation, and groundwater sampling should continue.
